Investigation of crack propagation in the surface white layer of rail steel

A. Yu. Perelygina, V. Yu. Konyukhov, A. E. Balanovskii

Irkutsk National Research Technical University (Irkutsk, Russian Federation)

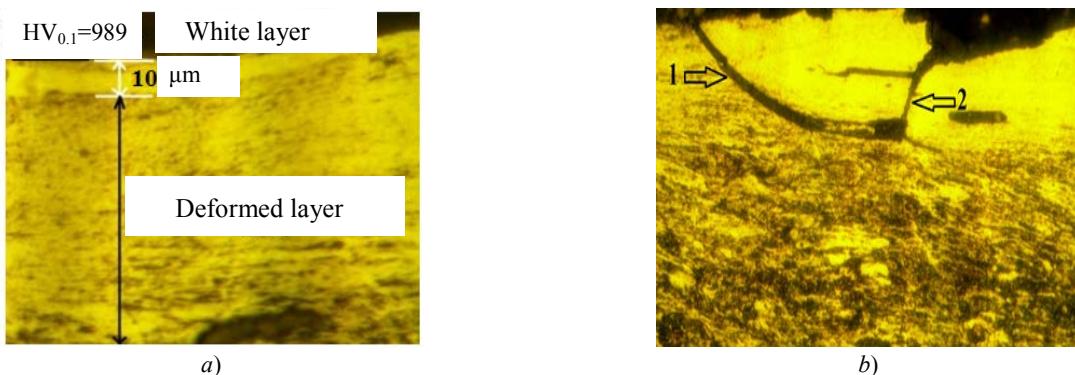
Fig. 2. Features of cracks in white layer on rail surface detected through optical microscopy: general view of white and deformed layer at 200-fold magnification (a); 1 - front edge crack, 2 - mid-position crack at 500x magnification (b)

Fig. 2a shows a segment of a white layer on the surface. Its depth is 10 μm . The microhardness value in the white layer is $HV_{0.1} = 989$. This corresponds to the *WEL* features presented in [4–15]. The *WEL* thickness can reach 200–300 μm depending on the operating conditions [4–6]. The image shows a sharp boundary between the white layer and the deformed pearlite structure of the basis rail metal. The depth of the plastic deformation zone between *WEL* and the basic rail material is $\sim 70 \mu\text{m}$. According to the estimates [5–10], on the pearlitic rails in operation, in the spot of the wheel – rail contact, plastic deformation has a high concentration creating a thin shear zone of 502,180 μm . At the same time, hardness tests show that due to volume contact, the depth of plastic deformation can reach 1–10 mm [4–9, 27–30]. This causes an important evolution of the microstructure on a narrower scale, i.e., to bend or rupture of cementite plates, to reduction of the inter-plate distance. The mechanical properties also change since the tensile strength increases and the fracture toughness decreases for cracks parallel to the aligned cementite plates. Two different cracks are located at the leading edge of the *WEL* (see Fig. 2b). They can originate and propagate at the interface between the *WEL* and the deformed pearlite microstructure. A detailed study on other samples showed that an inclined crack appeared on the leading edge of the *WEL* following the flow direction of the rail material. Then the crack went down into the rail material along the layer boundary. Fig. 2b shows a crack propagating vertically in the mid-position within the *WEL*. In the samples studied, two different types of cracks are observed at the trailing edge of the *WEL*. They are obtained from different *WEL* sections, but are located on the same rail sample and are very close to each other. The first-type crack originates and propagates along the boundary between the white layer and the plastic deformation zone (see Fig. 2b). The second-type crack crosses the interface with a deformed microstructure, but shows a tendency to curvature along the line in the direction of perlite shear strain. Such behavior of cracks is described in [4–7]. Indeed, the cracks studied by us are located in the same white layer; therefore, they were subjected to the same loads. However, their growth and development rates are different. This indicates a change in the state of stress in the leading, middle and rear position in the white layer. This means that the mechanism for the subsequent crack propagation (i.e., behind it) should be different. As shown in [35, 36], the plastically deformed structure of the perlite region directly below the white layer can play a significant role in effecting the crack propagation. Cracks that are formed due to fatigue when in the rolling contact can be divided into two categories according to the place of their origination: beneath the surface and on the surface.

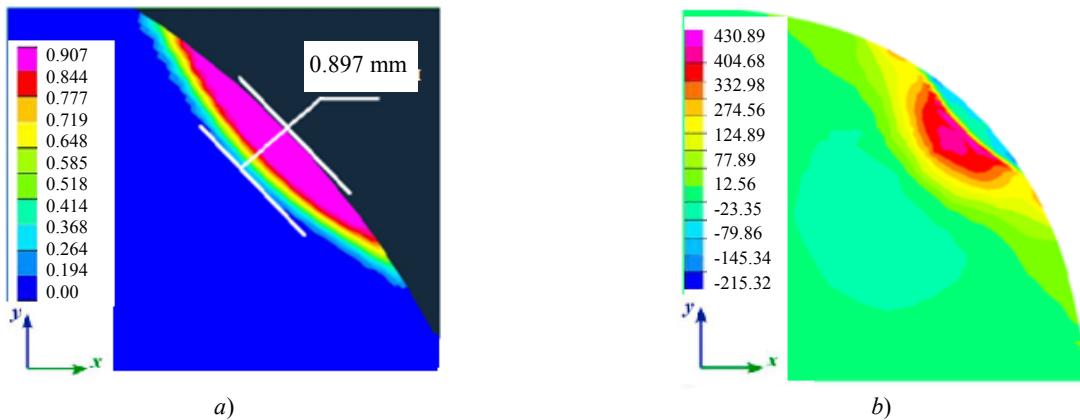
Fig. 3. Simulation results of white layer formation on the rail head surface in *SYSWELD* program: martensite fraction in the white layer, % (a); distribution of residual stresses in the white layer, MPa (b).

The white layer modeled in the program consists of martensite. The layer morphology is similar to that observed in the studied rail (see Fig. 2). The hardness of the simulated *WEL* is $670\text{--}810\text{ HV}$. This is slightly lower than in rails ($WEL \sim 725\text{--}1050\text{ HV}$). However, current simulations represent only one phase transformation cycle. From one to five repeated heat treatment cycles were simulated on the surface of the rail head. It is found that hardness increases to $700\text{--}850\text{ HV}$. Obviously, martensite with the same hardness as in the white layer of the rail can be obtained after several passes of the wheels. When modeling the formation of the white layer, it turned out that the temperature change during the wheel – rail contact and the distribution of residual stresses play an important role in this process.

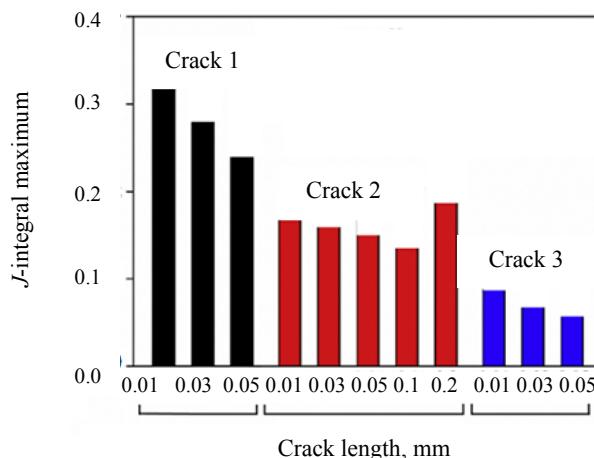
Fig. 4. Maximum values of J -integral at crack tips in the leading, middle, and trailing edges of *WEL* (crack length for calculation is chosen as 0.01 mm; 0.03 mm; 0.05 mm; 0.1 mm and 0.2 mm, separately)

It should be noted that the length of the crack is measured from the rail surface to the *WEL* depth. In the presented simulation version, cracks no. 1, 3 originate at an angle α and β (83.13°), the maximum load pressure is 1.2 GPa. At this, all three cracks have a length of 10 μm . At the top of crack no. 1, the value of the J -integral reaches a maximum of 0.321 N/mm. The maximum values of the J -integral for cracks nos. 2 and 3 are much smaller — 0.18 N/mm and 0.088 N/mm, respectively. The analysis of Fig. 4 shows that crack no. 1 at the leading edge of *WEL* is likely to grow compared to cracks in the mid-position and at the trailing edge. This fact is in agreement with rolling fatigue experiments [10–18]. It is shown that the boundary (beginning) of the white layer on the rail surface and the basis metal has the lowest resistance to the formation of a contact-fatigue defect, while the fatigue life at the end of the *WEL* is approximately 3 times higher than in the center and at the starting point. Fig. 4 shows that the maxima of the J -integral around the crack tips show a tendency to decrease with increasing length or depth. This phenomenon is more significant for crack no. 1 than for nos. 2 and 3. As the crack length increases, the maximum value of the J -integral for all three cracks decreases, respectively, from 0.3214 N/mm to 0.222 N/mm; from 0.18 N/mm to 0.14 N/mm and from 0.088 N/mm to 0.062 N/mm. This is consistent with the results of [19] since the deeper surfaces of the crack are less affected by normal and tangential contact loads. However, Fig. 4 shows that, for crack no. 2, when its length is 200 μm and corresponds to the *WEL* thickness, the J -integral maximum tends to the opposite, which has never been reported. In this case, the J -integral maximum is the largest in comparison with other short cracks no. 2. It can be assumed that crack no. 2 will rapidly propagate to the boundary between the *WEL* and the substrate. This is clearly seen in Fig. 2b (arrow 2). The significant difference is due to material irregularities between the perfectly elastic *WEL* and the elastic-plastic rail matrix. The calculation results show that for all three cracks the values of the J -integral decrease slightly when the crack length increases from 10 to 50 μm . If the deepening of crack No. 2 is from 50 to 100 μm , the change in the J -integral is relatively small. On the contrary, there is a significant increase in the maximum value of the J -integral if crack No. 2 propagates through the entire layer to the boundary between *WEL* and the rail matrix. The calculation results show that for all three cracks, the values of the J -integral decrease slightly when the crack length increases from 10 to 50 μm . If the deepening of crack no. 2 is from 50 to 100 μm , the change in the J -integral is relatively small. On the contrary, there is a significant increase in the maximum value of the J -integral if crack no. 2 propagates through the entire layer to the boundary between the *WEL* and the rail matrix.

The maximum value of the J -integral increases sharply with increasing load pressure from 0.8 to 1.5 GPa:

- from 0.27 N/mm to 0.53 N/mm for crack no. 1;
- from 0.17 N/mm to 0.47 N/mm for crack no. 2;
- from 0.04 N/mm to 0.1 N/mm for crack no. 3.
